PR: Disaster Flood in the Tigris – Made by a Turkish Dam

Press Release, 19.12.2018

Mesopotamia Ecology Movement
Initiative to Keep Hasankeyf Alive

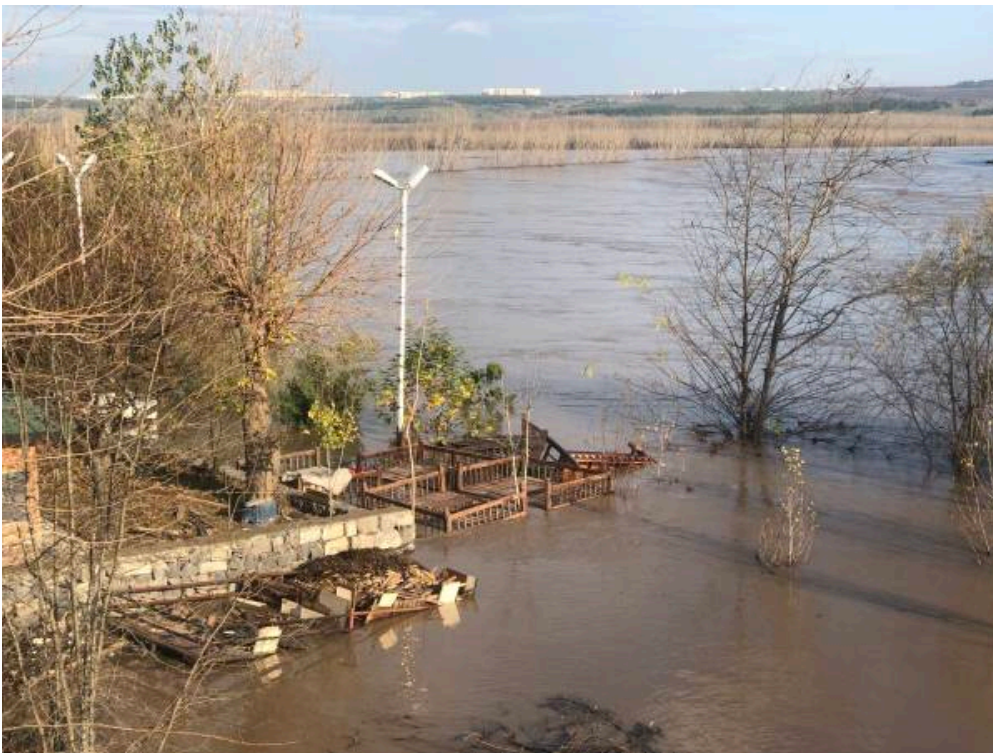
On the evening of the 13th December 2018 one of the three spillway gates of the Dicle Dam at the Tigris River in Turkish-Kurdistan has broken. Since then the water level in more than 200 km downstream river stretch increased up to 6 meters and flooded a big area of land along the river with hundreds of affected settlements. Fortunately nobody died, but the physical and agricultural destruction is enormous and unique for the last decades.
